SAN DIEGO CIREN

June 21, 2001

The San Diego CIREN Research Project

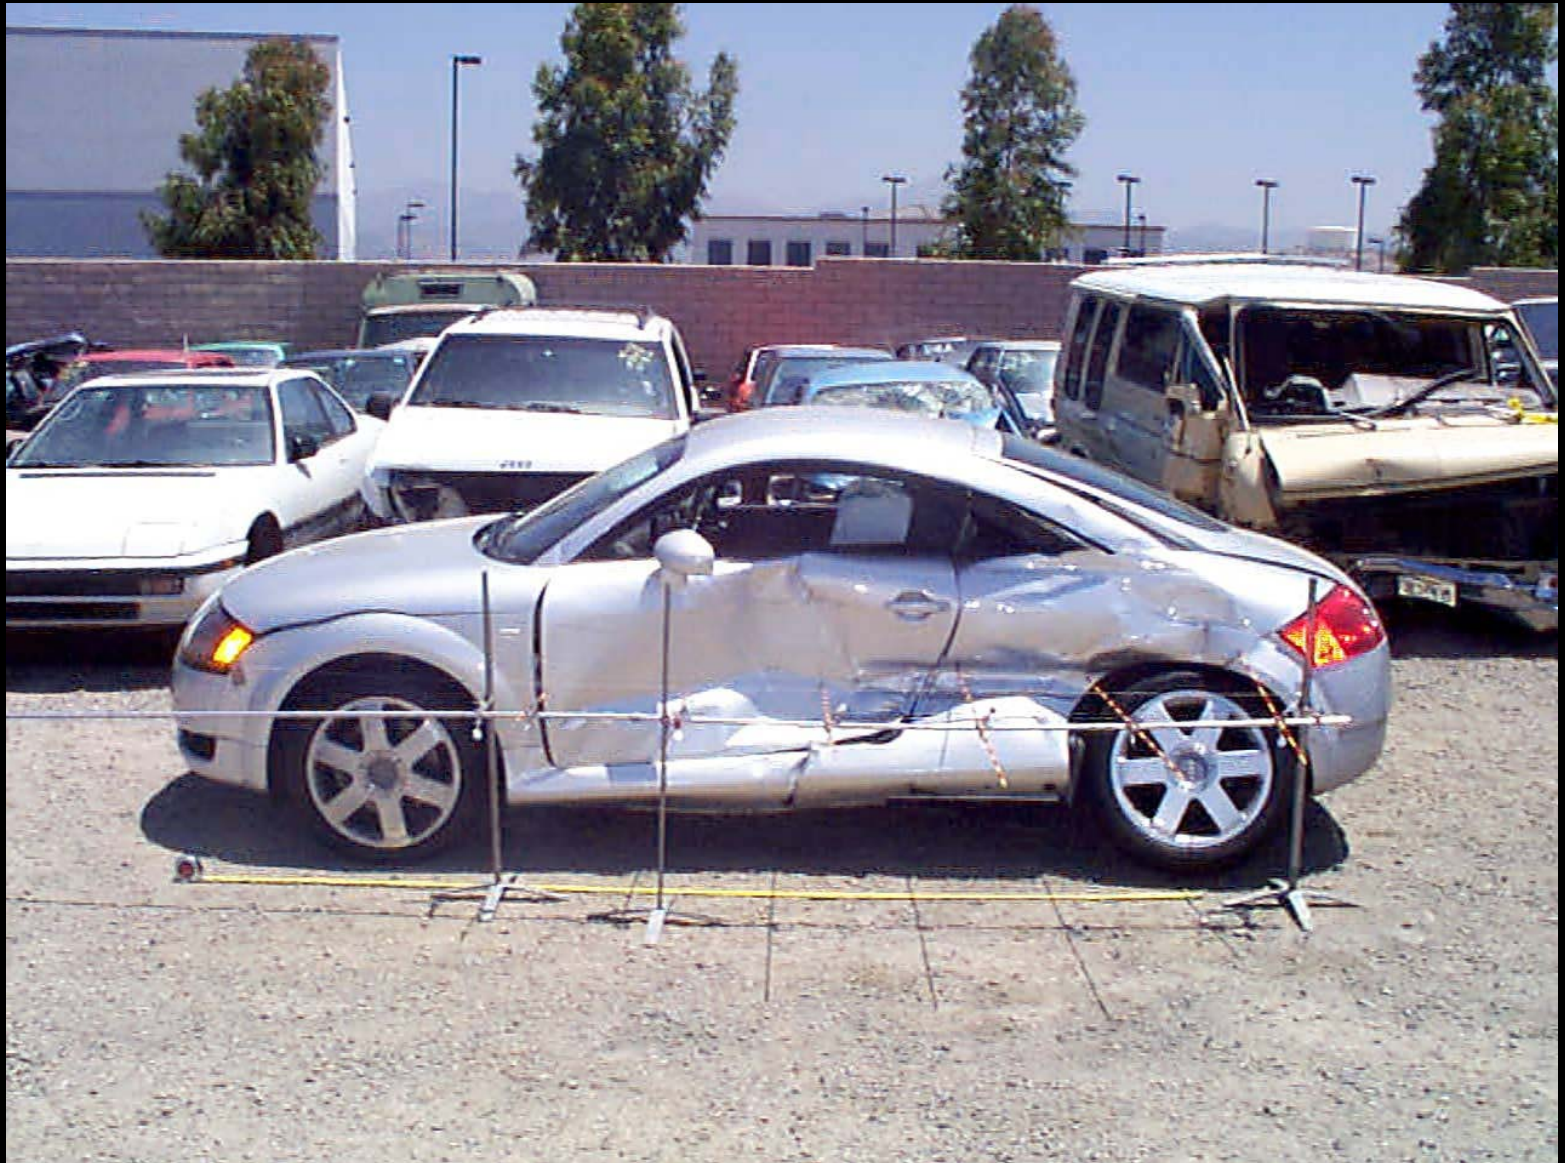
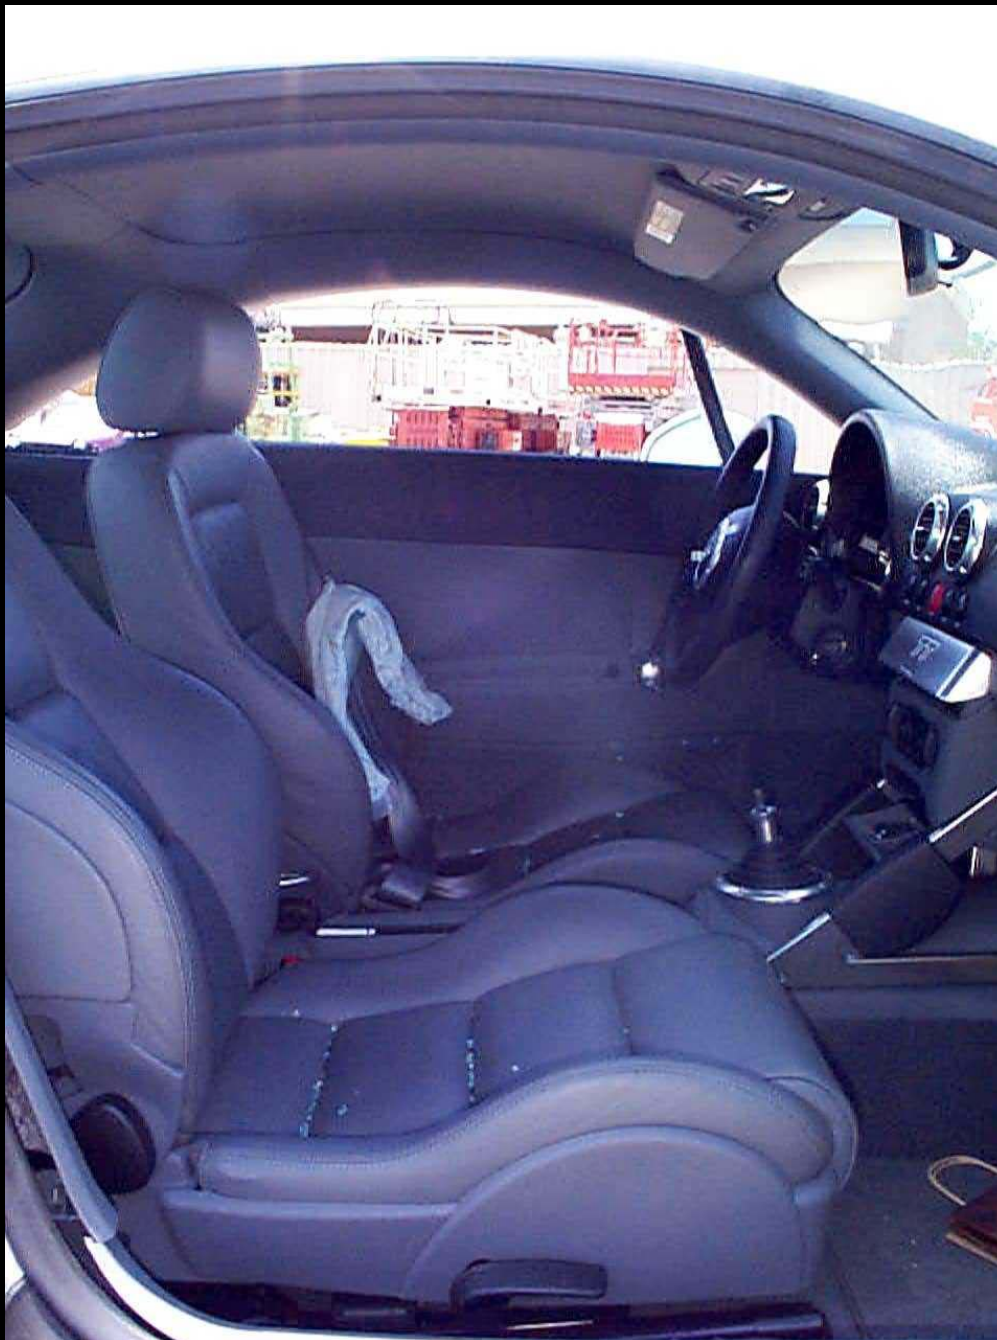
2000 Audi TT

Relevant Intrusions:

LF Door Panel -
17 cm

LF “B” Pillar -
10 cm

LF Front Seat
Back - 4 cm

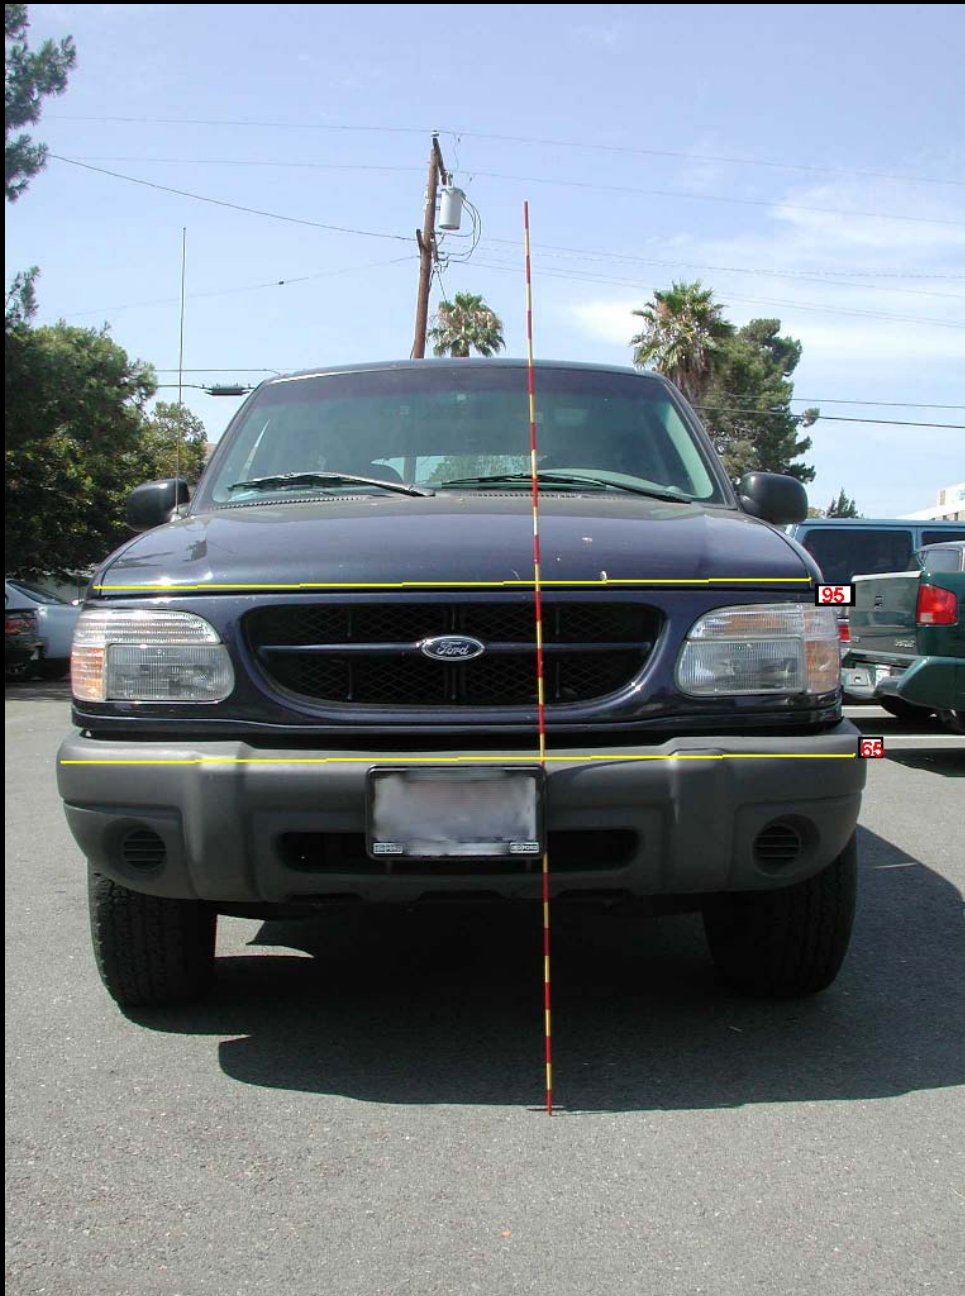
Exemplary '98 Ford Explorer

Front Plane Profile

Hood Edge Height
approx. 95 cm

Bumper Height @ top
approx. 65 cm.

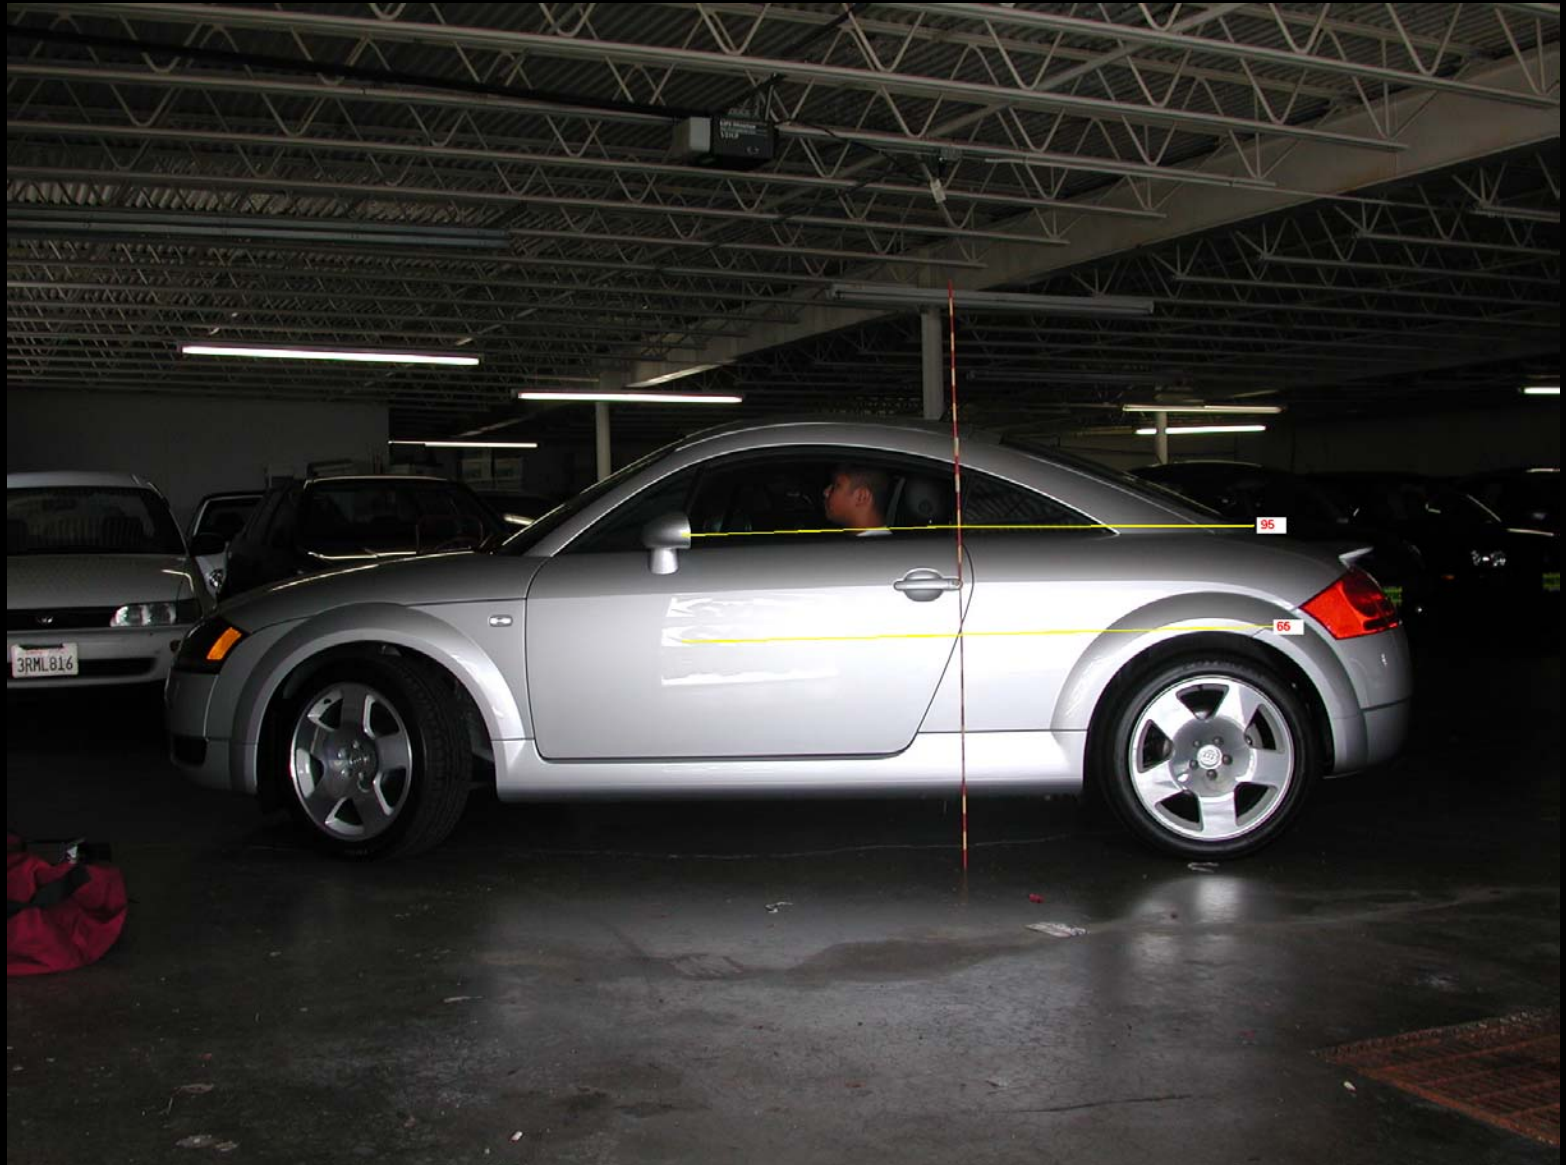
2000 Audi TT Occupied By Same Height Driver

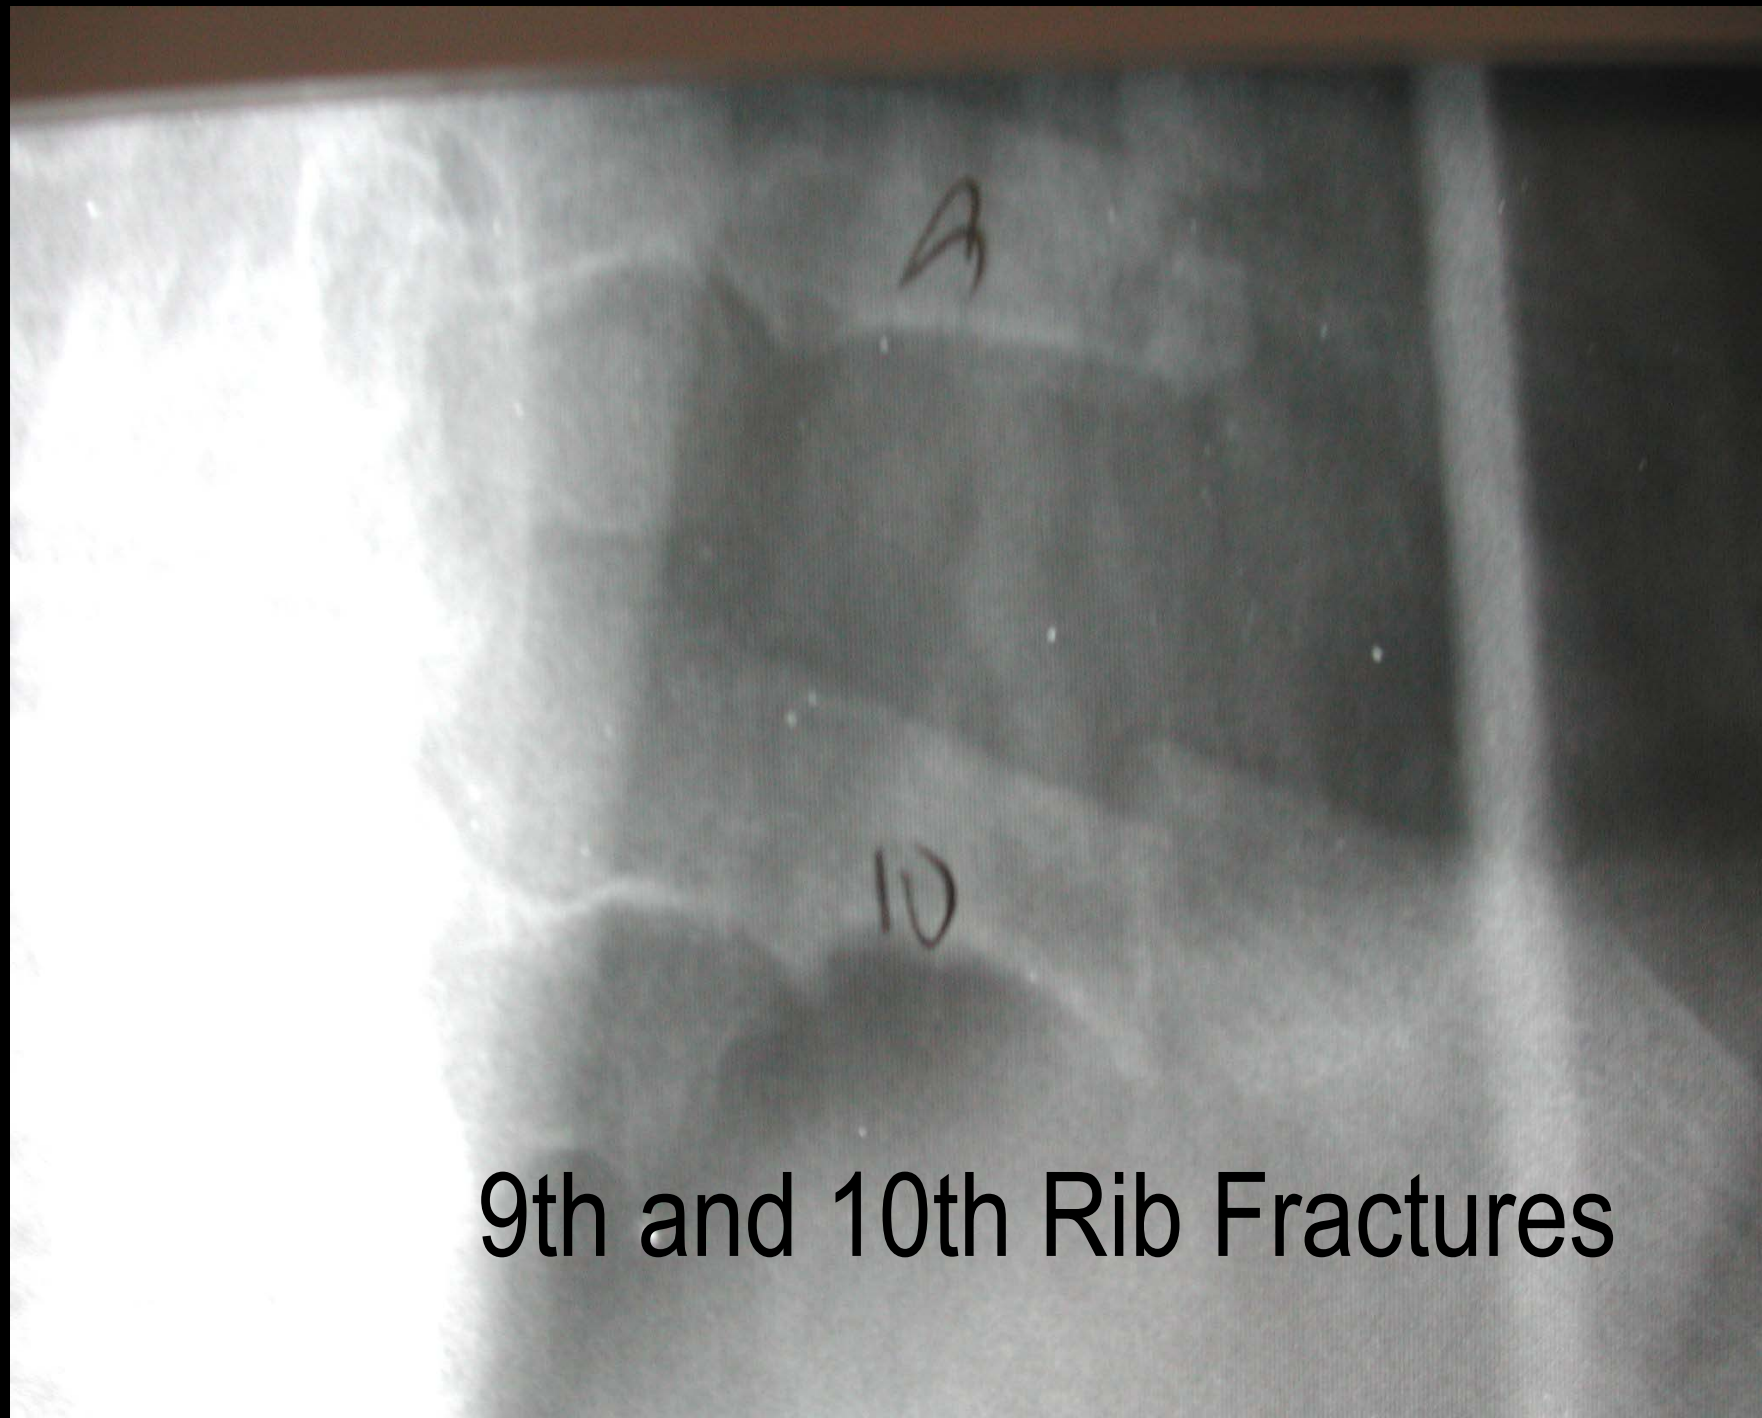
9th and 10th Rib Fractures

11th and 12th Rib Fractures

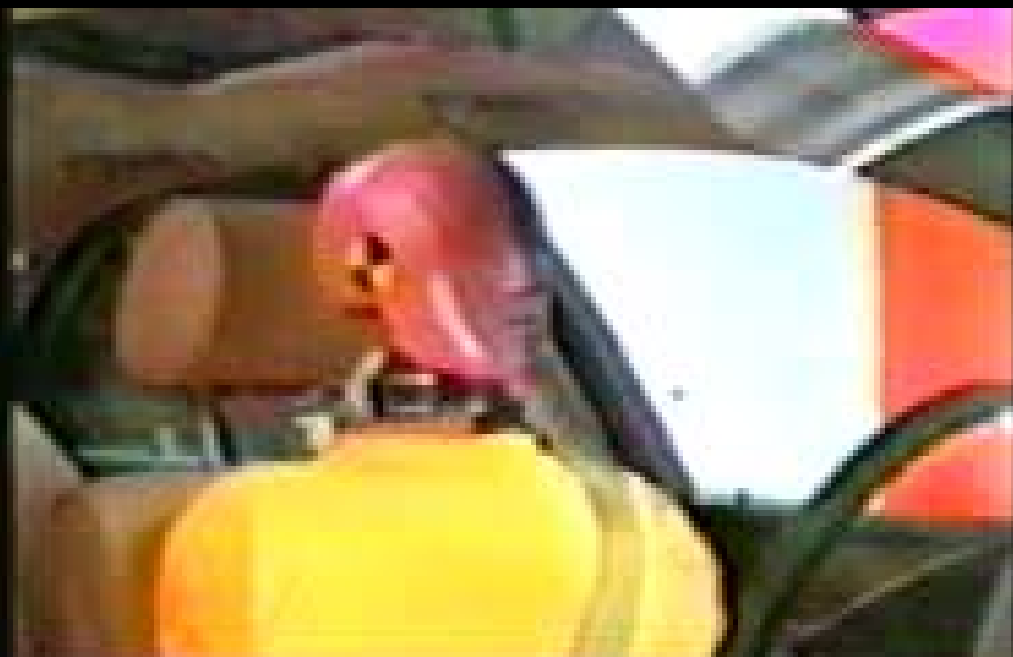
Without HPS

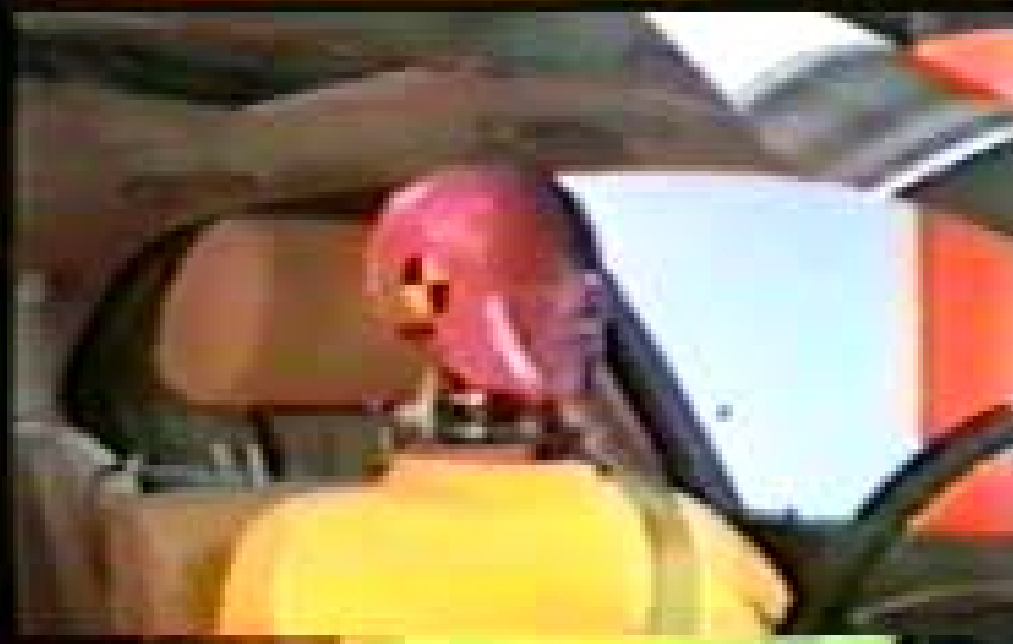
With HPS

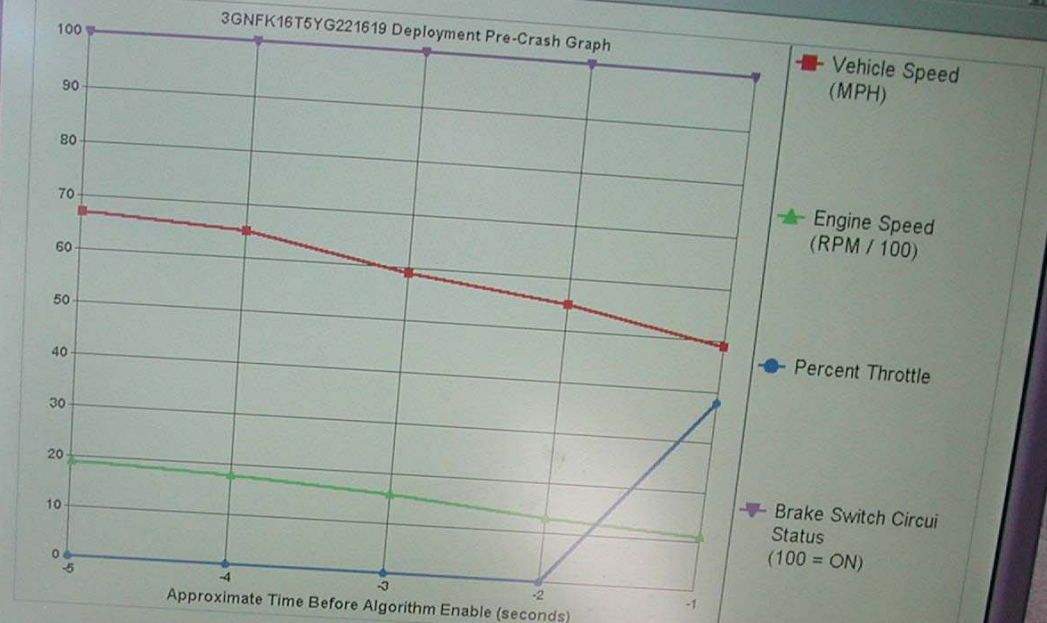
Crash Data Recorder

Events: DEPLOYMENT | NO Interface
